HEDDEN DUMP SITE
SANGAMO PCB STUDY
PICKENS, SOUTH CAROLINA
PROJECT NO. 87-032

U.S. Environmental Protection Agency
Environmental Services Division
College Station Road
Athens, Georgia 30613

HEDDEN DUMP SITE
SANGAMO PCB STUDY
PICKENS COUNTY, SOUTH CAROLINA

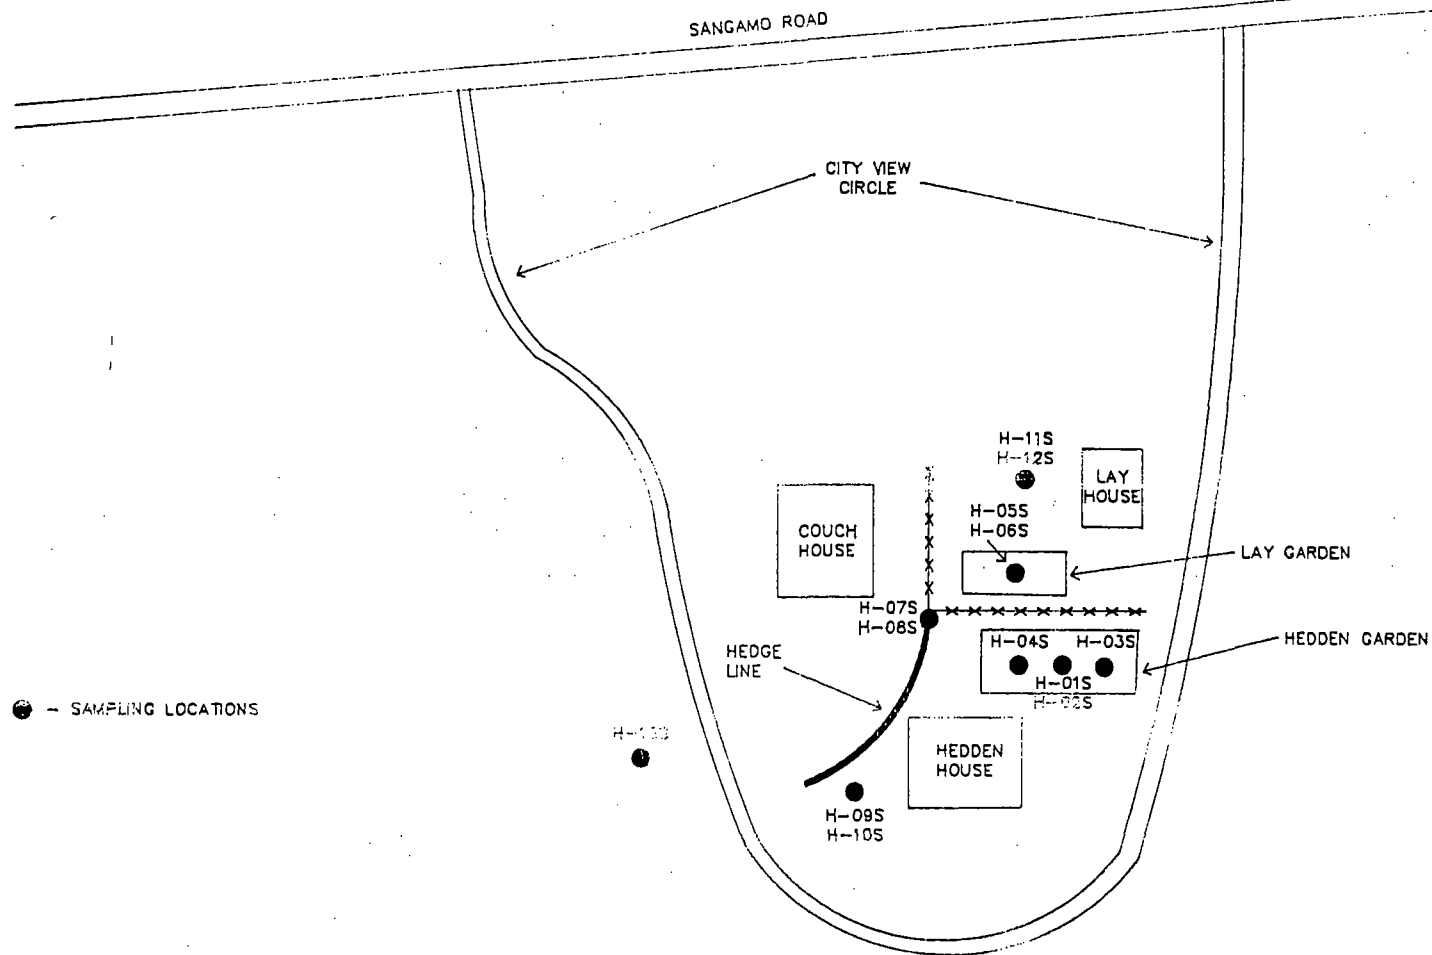
FIGURE 2
HEDDEN DUMP SITE
SKETCH(NTS)
PICKENS, SOUTH CAROLINA

Thirteen soil samples were collected from eight locations at this site. Sampling locations are described on Table 1 and shown in Figure 2. Analytical results for these samples are summarized on Table 2. Complete analytical results are included as Appendix A. Full organic compound and metals scans and analysis for cyanide were requested for only one sample (H-01S) collected at this site. PCB analyses, only, were requested for the other twelve samples. Surface water and sediment samples were not collected because no surface water, streams or ditches were located in the dump site area. Ground water samples were not collected because there were no potable wells in the area. All area residents are on the city water system.
